GT2017-63807

DEVELOPMENT OF A COMBINED EDDY CURRENT AND PRESSURE SENSOR FOR GAS TURBINE BLADE HEALTH MONITORING

V. Sridhar and K. S. Chana

Osney Thermo Fluids Research Laboratory
Department of Engineering Science
University of Oxford
Oxford, United Kingdom

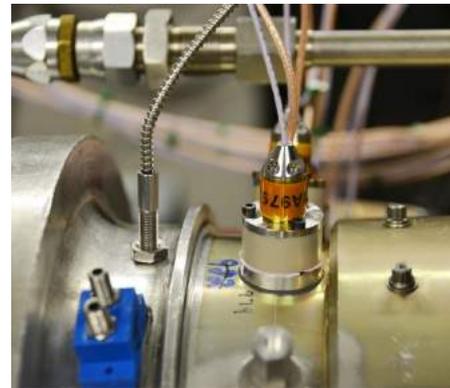
Experimental measurements were carried out using the combined pressure and eddy current sensor developed at the University of Oxford and Oxsensis[®] as shown in Fig. 1a. The sensor has a diameter of 13 mm and six sensors were used for the measurements along the 180 degree of the circumference.

The combined probes were manufactured in peek Polyether Ether Ketone (a semi crystalline organic polyether thermoplastic) which is an aerospace approved material. The probe has a temperature capability of 250°C continuous and 320°C intermittent. However, the sensor is actually capable of operating at higher temperatures around 500 to 600°C with different probe materials. The probe has a diameter of 13 mm.

(a) Combined sensor

The Oxsensis[®] pressure sensor is used for monitoring dynamic pressures in harsh environmental conditions with temperatures up to 1000°C at the tip of the sensor. The transducer element uses an optical Fabry-Perot cavity made from crystalline sapphire. The sapphire membrane is deflected under the influence of the pressure to be measured and the corresponding change in cavity size is detected optically using interferometry. A dual wavelength scheme is employed to eliminate adverse effects of fibre bending losses that may occur in a high-vibration environment. The sensor can also provide temperature as an additional parameter of interest which allows compensating for the thermally induced changes in cavity size and thus, enabling the measurement of (quasi)-static pressure at the same time. The enhanced sensor has an accuracy of < 2%FS. The Oxsensis[®] signal processing unit combines all of the optical components with the required electronics to produce a calibrated pressure output.

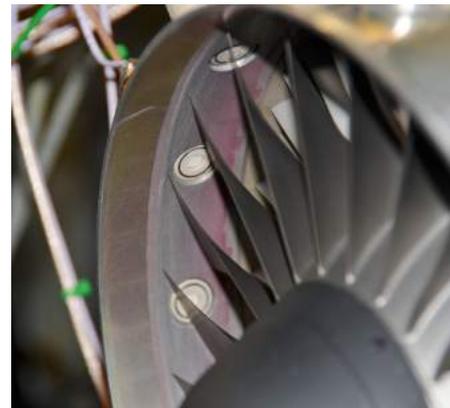
Six probes were fitted to the casing of the fan over the first stage fan blade as shown in Fig. 1b. Figure 1c shows the sensor locations around the casing from the top dead centre position.

(b) Sensor on the engine

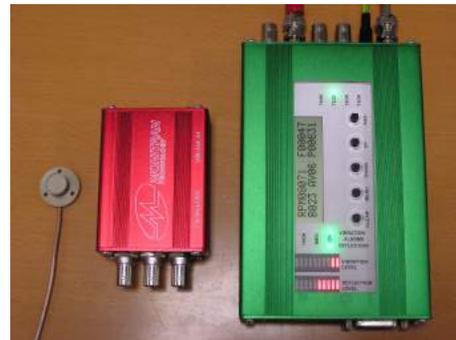
(d) T3 and Monitoring box

The eddy current sensor part of the probe goes to a small electronics box called the turbine-tip-timing unit (T3) (Fig. 1d). The T3 box drives the probe and also processes the signal in a manner that it separates the tip clearance from the blade arrival time information. The T3 outputs time of arrival trigger pulse, the raw eddy current sensor signal and scaled tip clearance. The T3 output is then sent to a tip-timing PC.

For the dynamic pressure part of the probe, the signal is transmitted via a standard fibre optic cable to an Oxsens signal conditioning and driver box and then the output from the box is fed to a National Instruments high speed DAQ. The data was sampled at 1 MS/s per channel. The probe cable was extended using standard 12 m fibre extension cables to reach the control room where the electronics were situated. The 12 m fibre extensions did not degrade the signal quality.

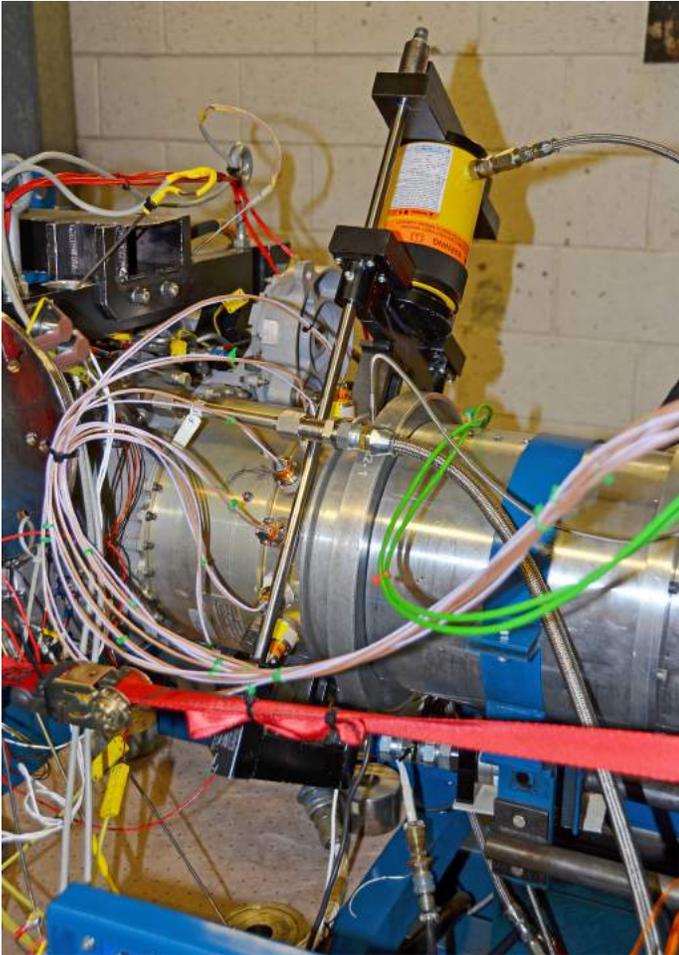
The mechanism used to distort the casing is shown in Fig. 3, where a hydraulic ram is fitted to the casing at about the 2 o'clock position with a frame that fits around the casing and anchors on the opposite side. The anticipation was that the casing would be squeezed and a rotor tip rub would be induced in the region of probe 6 at the 0° position where probe 6 was mounted and, depending on the stiffness of the casing an increase in diameter may be experienced at 90° from the squeeze point. Surprisingly during the squeeze process, the eddy current part of the combined probe at location 6, nearest the squeeze region, showed an increase in tip clearance rather than a reduction. This was monitored in real time and this entailed that the squeeze process had increased the diameter of the casing at the probe 6 location as opposed to reducing it. Following the initial test, the casing was left in the squeeze position and the clearance measured around the casing between the fan blade tip and the casing had increased at the probe 6 location, reduced at the hydraulic ram location to a point where the blade was touching the casing and remained similar elsewhere around the annulus. At the probe 6 location the clearance had grown by 30 thou and explained the sensor measuring an increased clearance. The reason for the increase is that as the casing was squeezed it caused it to distort only locally in a manner where it became "M" shaped i.e. reduced in the centre of the squeeze location and raised just to the sides.

FIGURE 3: Hydraulic ram to squeeze the casing

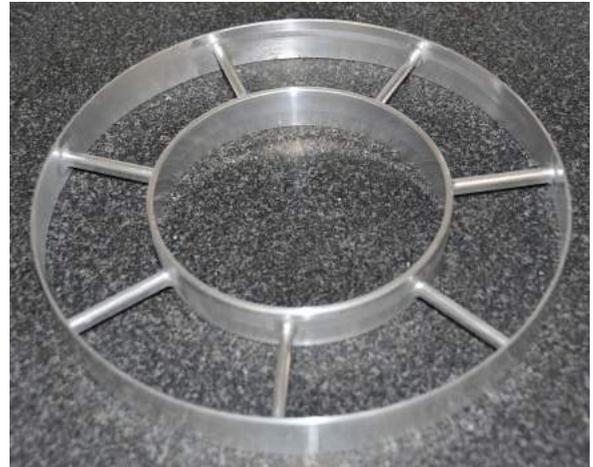
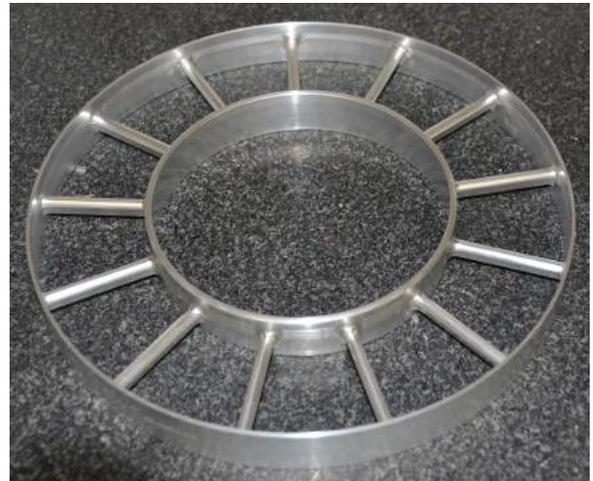
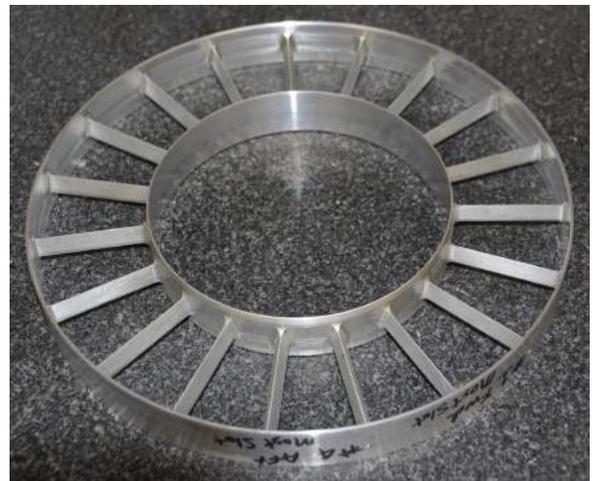
The inlet aerodynamic distortion tests were performed by introducing a set of bars fitted in the inlet duct of the engine upstream of the fan blade row. Three rings were tested separately that contained 7, 13 and 19 bars (Fig. 6). The bars are in aerofoil

shape with the thicker section downstream to produce a thicker wake in the flow. Figure 7 shows the engine fitted with the 19 bar ring, the rings have a hub and casing circular ring interconnected with a series of bars that are profiled in shape.

FIGURE 6: Bars used in the experiments for inlet distortion
