GT2017-63803

TIP-CLEARANCE MEASUREMENTS ON AN ENGINE HIGH PRESSURE TURBINE USING AN EDDY CURRENT SENSOR

V. Sridhar and K. S. Chana

Osney Thermo Fluids Research Laboratory
Department of Engineering Science
University of Oxford
Oxford, United Kingdom

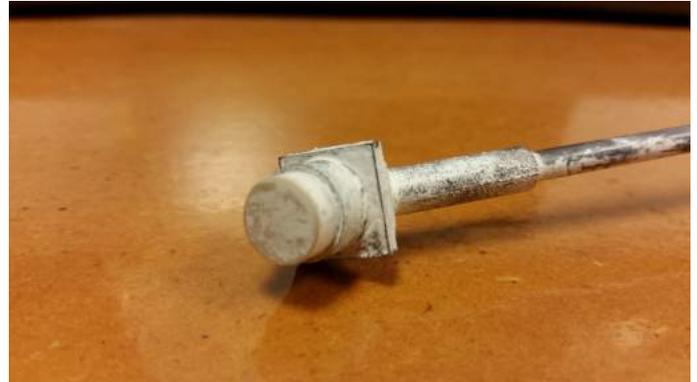
(a) Eddy current sensor

FIGURE 1: Hot eddy current sensor and mounting

Figure 1a shows the high temperature eddy current probe developed at the University of Oxford. The sensor has a diameter of 10 mm and is enclosed by an Inconel 625 casing to withstand high temperatures ($> 1000^{\circ}\text{C}$). The sensor has a coil with set number of turns and when a high frequency alternating current is sent to the coil, a magnetic field is induced. This field couples in to a conductive target and this coupled field generates reversed eddy currents. These eddy currents oppose the source magnetic field which changes the apparent inductance of the coil. An electronic circuit was built to generate the high frequency alternating current and to detect changes in the phase of the received signal against the source.

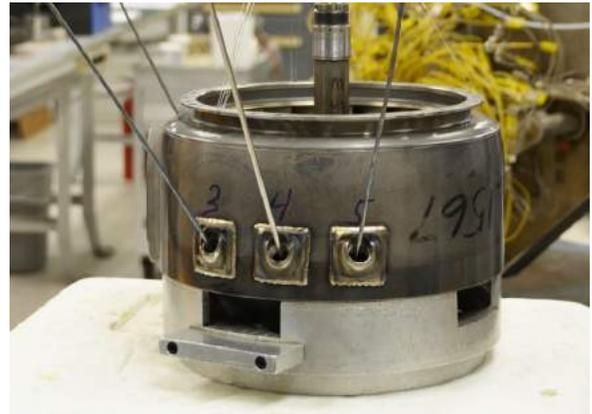
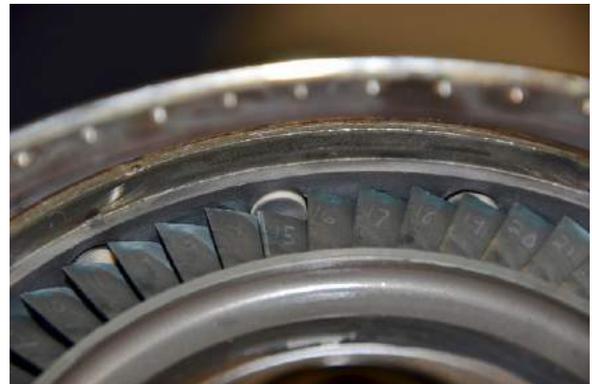
(b) Probes on the turbine casing

(c) Probes seen in the turbine casing

The experimental setup consists of a small gas turbine engine with sensors placed in the first stage of the turbine as shown in Figs. 1b and 1c. Two blades were reduced in height for testing the sensor. The data acquisition system comprised of a Cleverscope[®] oscilloscope along with their proprietary data acquisition software. The data was acquired at 10 MS/s and the

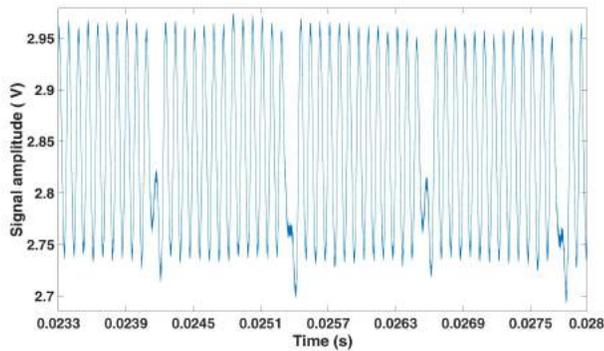
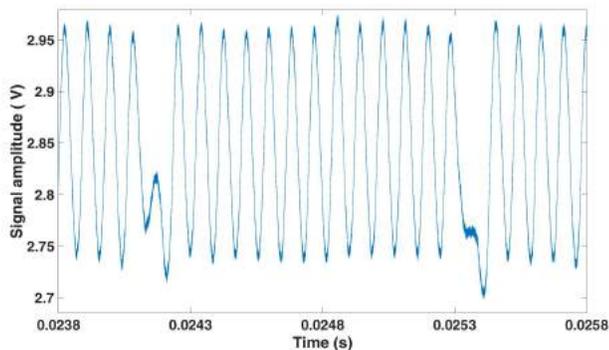
(a) Signal from the sensor

(b) Zoomed in view of the signal

FIGURE 2: Tip clearance signal during air cranking

tion chain prior to the actual engine run. Figure 2a shows eddy current sensor data from the HP turbine during an air crank for just over one revolution of the HP turbine. The gaps between the peaks are blades that were reduced in height as mentioned earlier. These blades helped in providing a once per rev reference. Four blades were reduced in total, two by approximately 2 mm and two more by approximately 4 mm. An issue one might face was detecting two blades at once due to the physical size of the eddy current sensor relative to the blade spacing at the tip. By reducing the blade height, the probes would at least have detected some blades individually. However, the current measurements (Fig. 2a) clearly show that each individual blade is detectable with the eddy current sensor and furthermore we see good quality of signal from the zoomed in view in Fig. 2b. Now, the relative tip clearance between the blade tips can be measured with the height of the peaks of the signal.

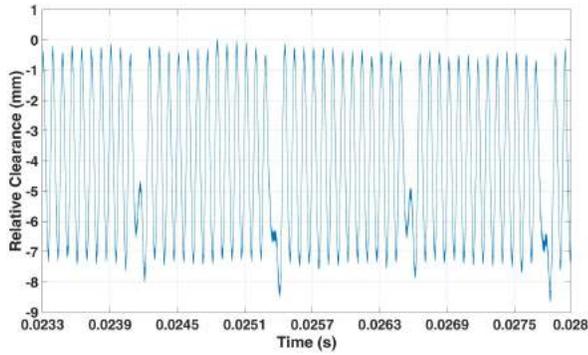
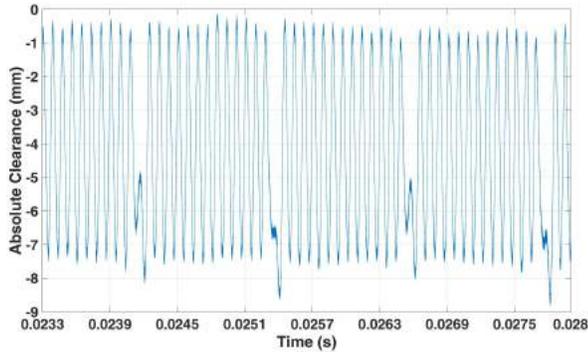
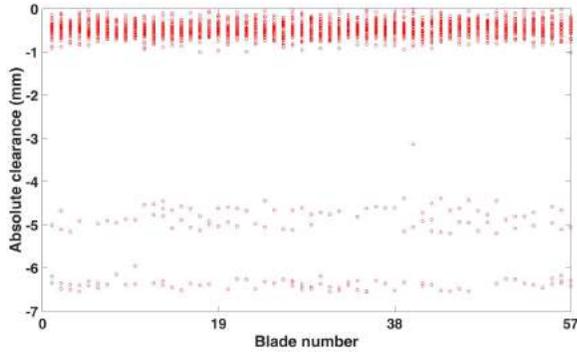
(a) Relative clearance at 10000 RPM

(b) Absolute clearance values at 10000 RPM

(c) Zoomed in view of the peak

FIGURE 3: Clearance values at 10000 RPM

Figure 3a gives the relative clearance values for the air crank test at 10000 rpm i.e. with respect to each blade and not the casing. The peaks of the signal represent the tip of the blade. The tallest blade is set to the zero position. This was done to show how the clearance of each blade varies with other blades and the shortened blades are clearly seen here and they are in good agreement with the measurements provided by the engine manufacturer of the amount the blades have been reduced by. Figure 3b gives the absolute clearance variation for each blade and figure 3c shows the peak clearance values of the blades for the run and we see some variation in the clearance values.

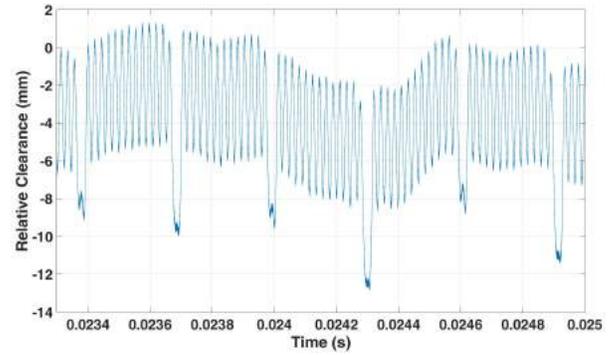
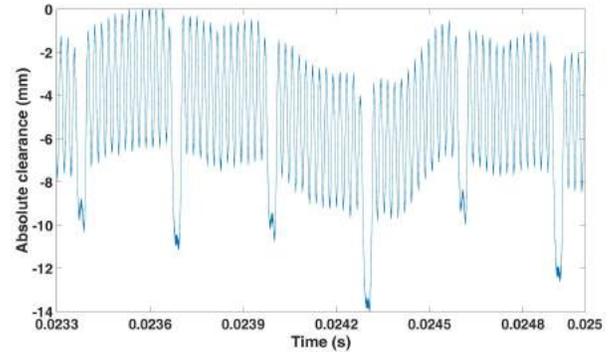
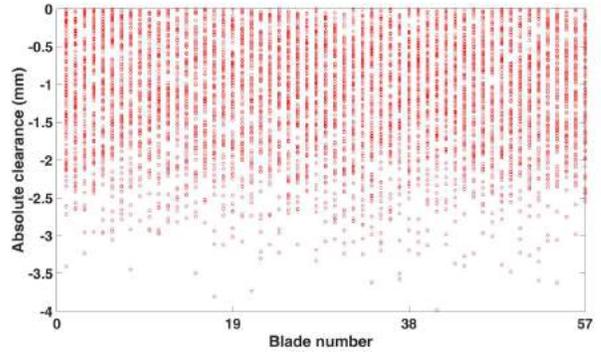
(a) Relative clearance at 43000 RPM

(b) Absolute clearance values at 43000 RPM

(c) Absolute clearance values at 43000 RPM

FIGURE 4: Clearance values at 43000 rpm

Once several air cranks had been completed the engine was fired and brought to idle speed of 23000 rpm which is around 43,000 rpm for the HP shaft. Figures 4a and 4b shows eddy current sensor measurements of relative and absolute clearances from a fired engine run. Notably the data the sensors to be operating and also shows some low frequency overlapping on the signal. Firstly, the variation in the peaks is greater than the air crank data and there seems to be a repeatable pattern to the variation. The repeatable pattern is caused by a whirling of the shaft with reference to the casing. However, the tip clearance between the different blades is easily detectable. We also note that the variation in absolute clearance values has increased quite a lot as shown in Fig. 4c, which is also indicative of increase in whirling of the shaft. Finally, figure 5a shows the measurements of relative clearance values at higher speeds. The data shows that the probe has measured very good quality signals at the higher operating conditions of speeds, temperatures and pressures as well as vibrations. The whirling is more apparent at higher engine speeds where a sinusoidal variation is clearly observed (Fig. 5b

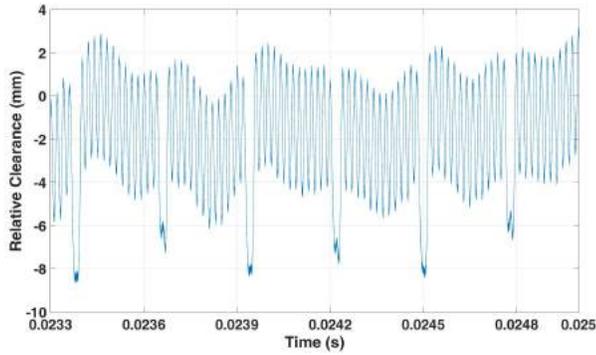
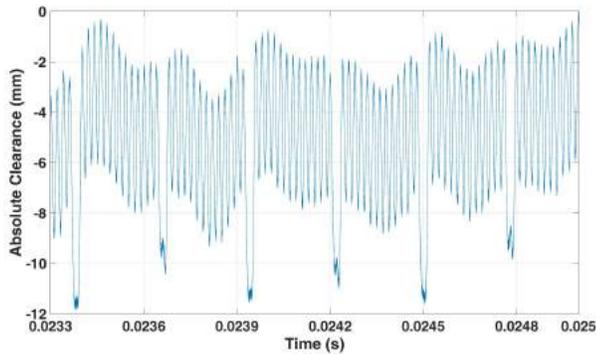
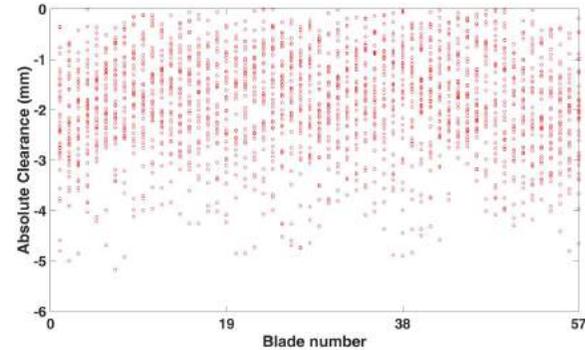
(a) Relative clearance at 49000 RPM

(b) Absolute clearance values at 49000 RPM

(c) Zoomed in view of the peak

FIGURE 5: Clearance values at 49000 RPM

and 5c), which is not unusual for rotating turbomachinery. The statistical analysis of the absolute clearance values with respect to blade numbers show that as the speed increases, the variation in clearances increases from 1.097 mm to 1.32 mm.

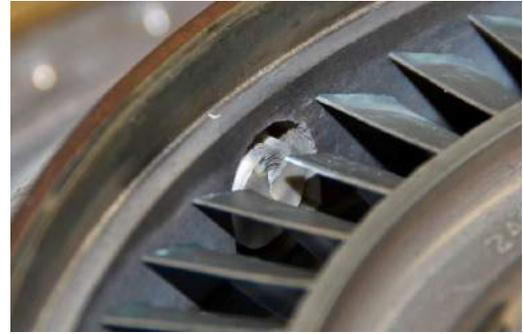
(a) Damaged sensor in the engine

FIGURE 6: Tip rub of the sensor

A post-test analysis was carried out on the high temperature probes once the trials were completed and the probes recovered after the engine was dismantled. Surprisingly the eddy current sensor probes were found to have been damaged during the test. Figure 6 shows the damage to the various probes. During fit-

ting the probes were slightly angled and the forward part of the face was slightly closer to the casing on the gas path side than the rear of the sensor, towards the cable exit. Figure 6a shows the damage to one of the eddy current sensor probes inside the turbine. In general the probe body and cable is in very good condition, however the 3 eddy current sensor probes have cracked ends with small parts missing.

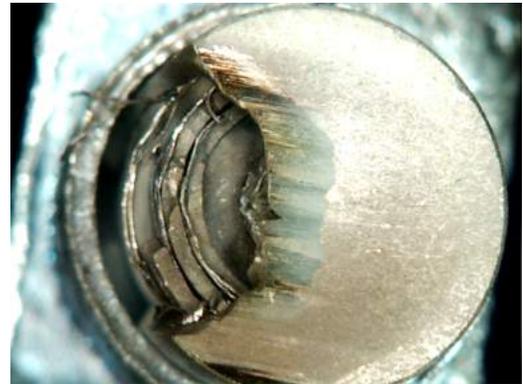
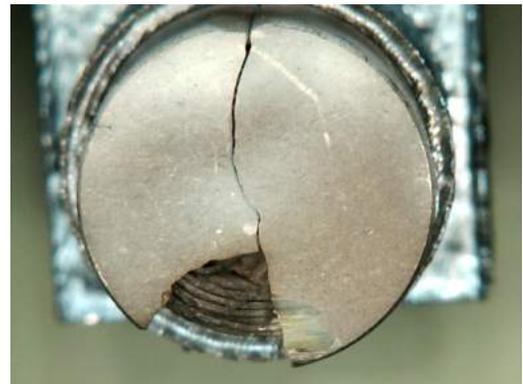
(b) Damaged sensor 1 due to tip rub

(c) Damaged sensor 2 due to tip rub

ures 6b and 6c show the close-up photographs of the probe tips. The pictures show evidence that the probe tips suffered a rotor blade tip rub, the area where the blade came into contact with the probe can be clearly seen. The most likely cause of the tip rub was following a shut down the probes had thermally grown and the casing had cooled sufficiently that the probes were protruding through the casing. When the engine was restarted, the rotor expanded thermally and due to the rotation and centrifugal force a rub was experienced on the casing and the probe tips on the
